**MTA Climate Adaptation  
Task Force**

**2019 Resiliency Report**  
Update on  
agency-wide climate  
resiliency projects

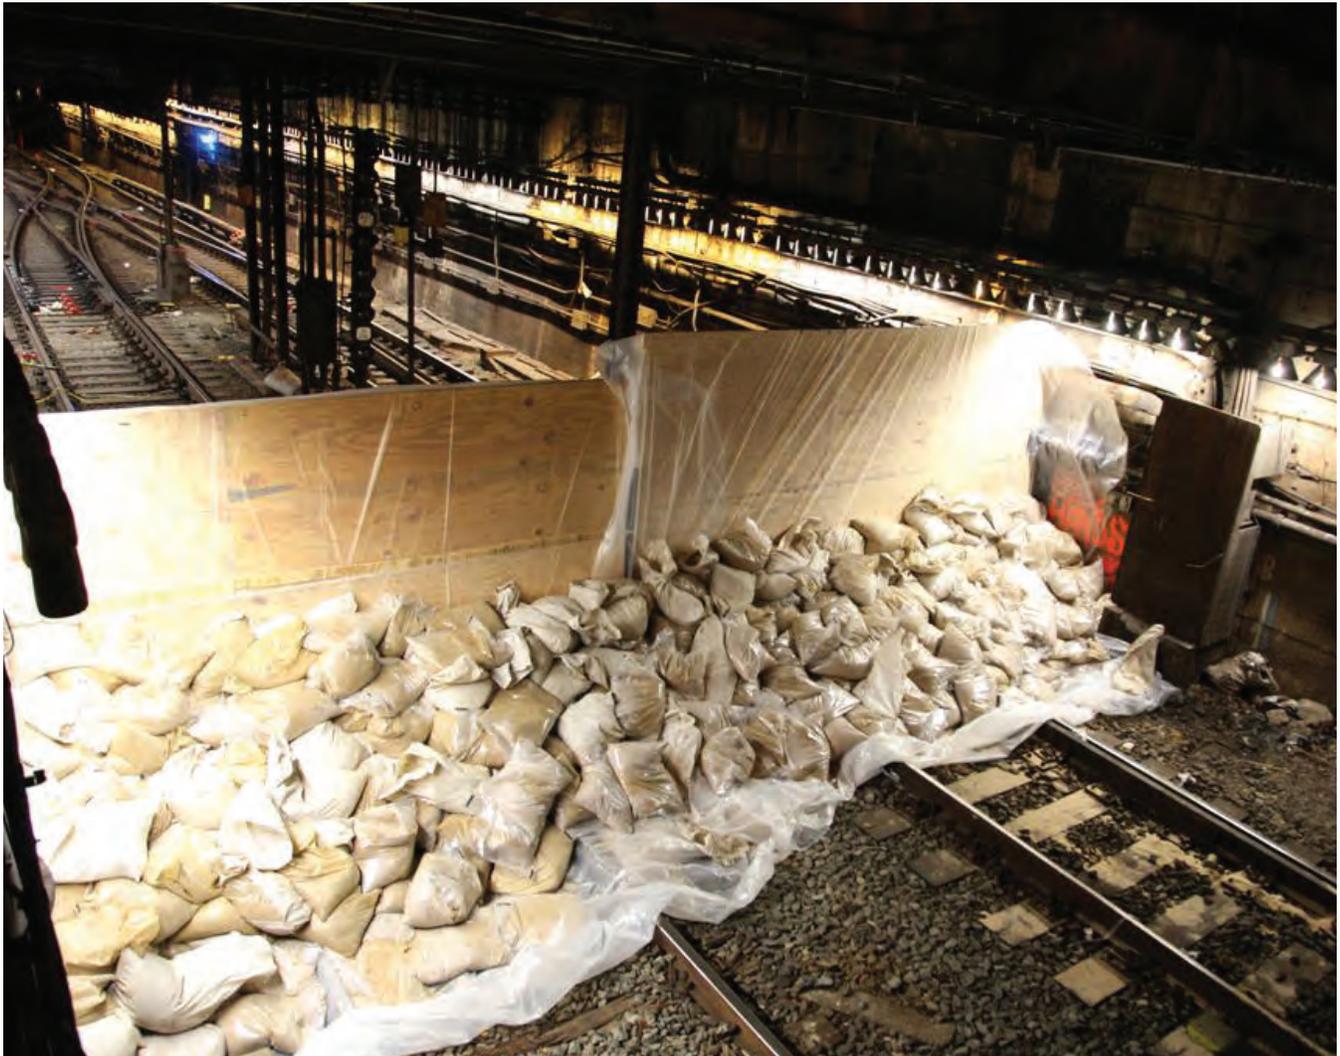
FIGURE 1: PROTECTION OF 148 STREET PORTAL BEFORE SUPERSTORM SANDY.

*Project Description:* Located where tracks emerge from the subway to the above-ground terminal station, the 148th Street Portal is extremely vulnerable to flooding from the nearby Harlem River. The project will mitigate flooding of the portal and adjacent tunnels through a system of flood logs that can be deployed within hours of an oncoming storm. This replaces the labor-intensive and less reliable temporary wooden barrier demonstrated below.

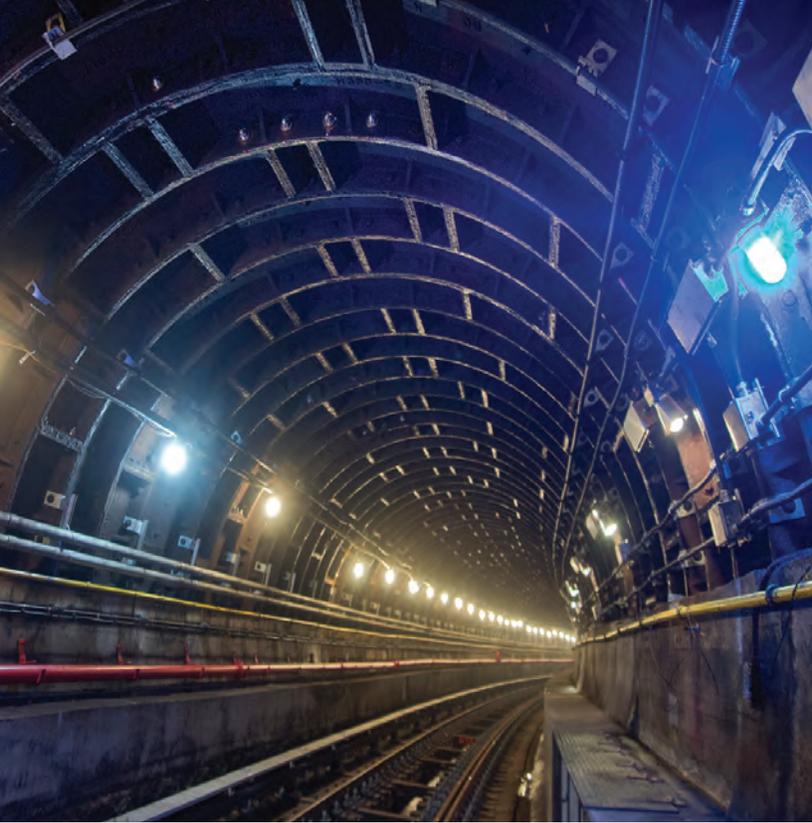
FIGURE 2: RESTORED MONTAGUE TUBE.

*Project Description:* During Superstorm Sandy, the Montague Tube, the under-river subway tube servicing the R subway line, flooded at a length of roughly 4,000 feet and a depth of 20 feet with 27 million gallons of debris-filled saltwater. The extensive damage suffered from the storm required complete shutdown of the tube from August 2013 - September 2014. In addition to restoration, resiliency measures completed in this project included the installation of marine cabling, hardening of pump systems, and protecting the electrical facilities with watertight doors

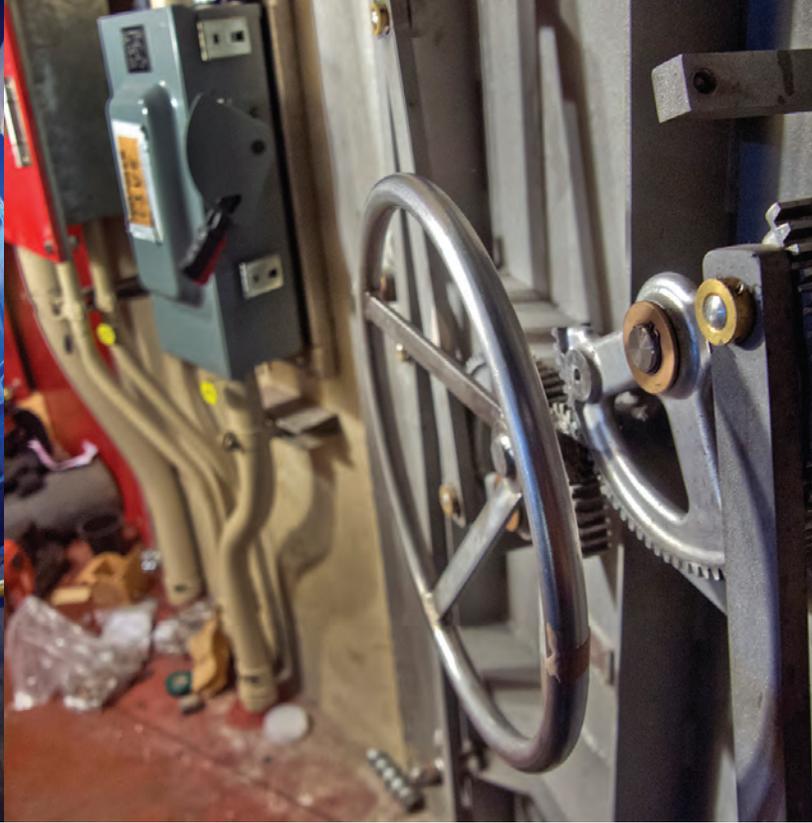
FIGURE 3: NEWLY INSTALLED WATERTIGHT DOORWAY.

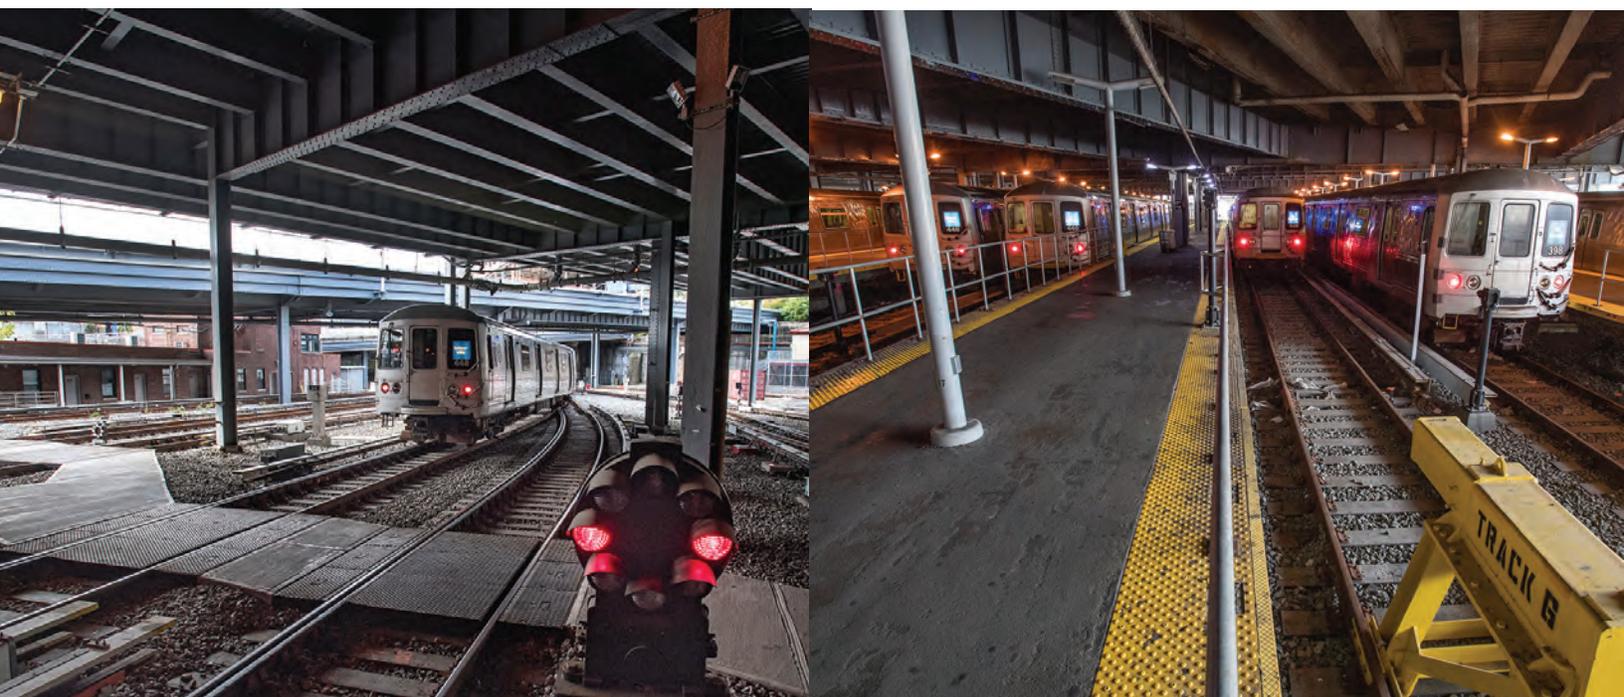
FIGURE 4: ST. GEORGE TERMINAL WITH NEW, FLOOD RESILIENT RECYCLED PLASTIC TIES.

*Project Description:* St. George serves as the Staten Island Railway’s main terminal. Superstorm Sandy flooded all twelve tracks and overwhelmed the terminal’s drainage capacity. In addition to restoration, this project includes resiliency measures such as a permanent flood barrier, improved drainage systems, and more water resistant, recycled plastic track tie infrastructure.

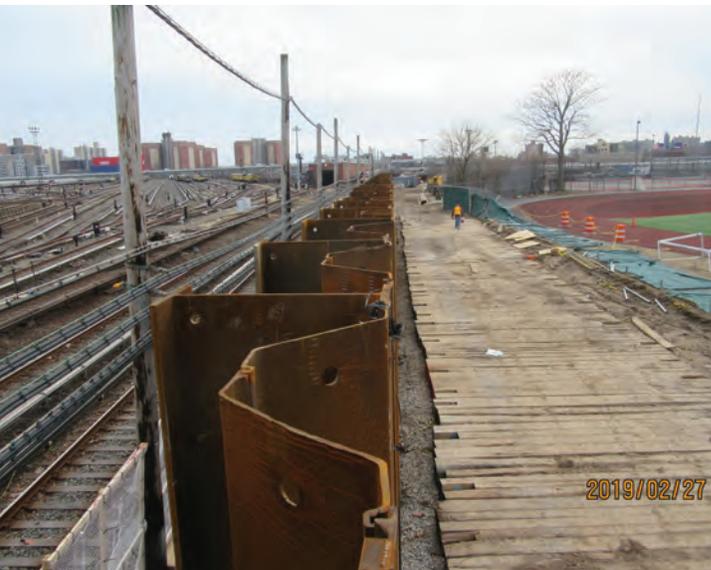
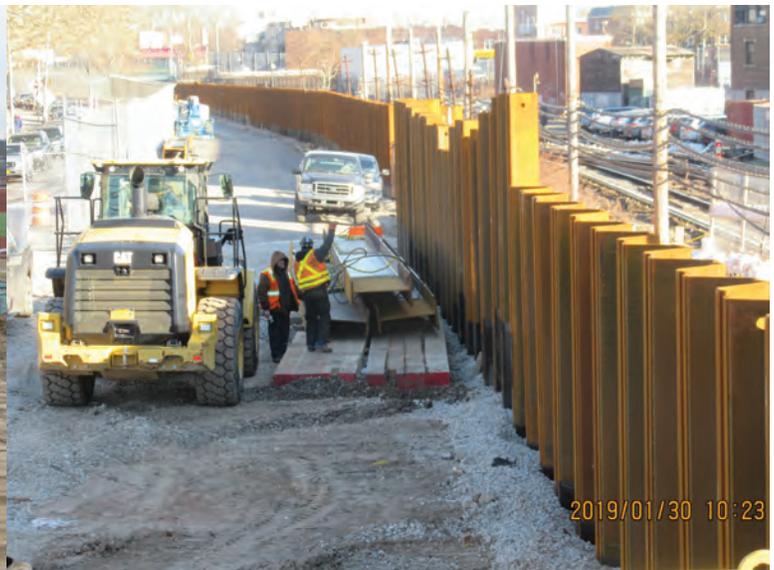
FIGURE 5: INSTALLATION OF THE PERMANENT PERIMETER FLOOD BARRIER AT CONEY ISLAND YARD.

*Project Description:* After Superstorm Sandy caused extensive flooding in this critical train yard, near-term and long-term flood mitigation measures were implemented to address critical climate vulnerabilities. Near-term projects include a temporary perimeter barrier and improved drainage to prevent pooling. Longer-term projects, funded entirely by an FTA resiliency grant, include a permanent flood barrier wall and drainage improvements.

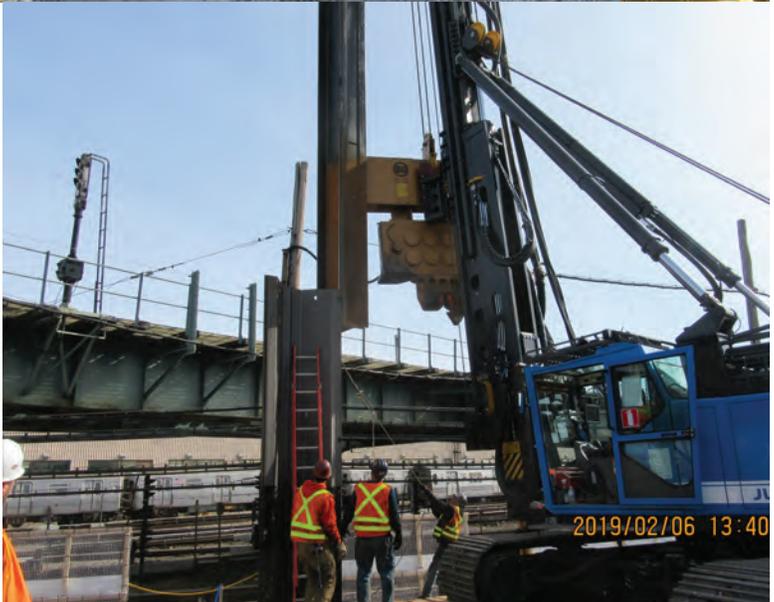
#### Coney Island Yard

Near-term projects include a temporary perimeter barrier and improved drainage to prevent pooling. Longer-term projects, funded entirely by an FTA resiliency grant, include a permanent flood barrier wall and drainage improvements.

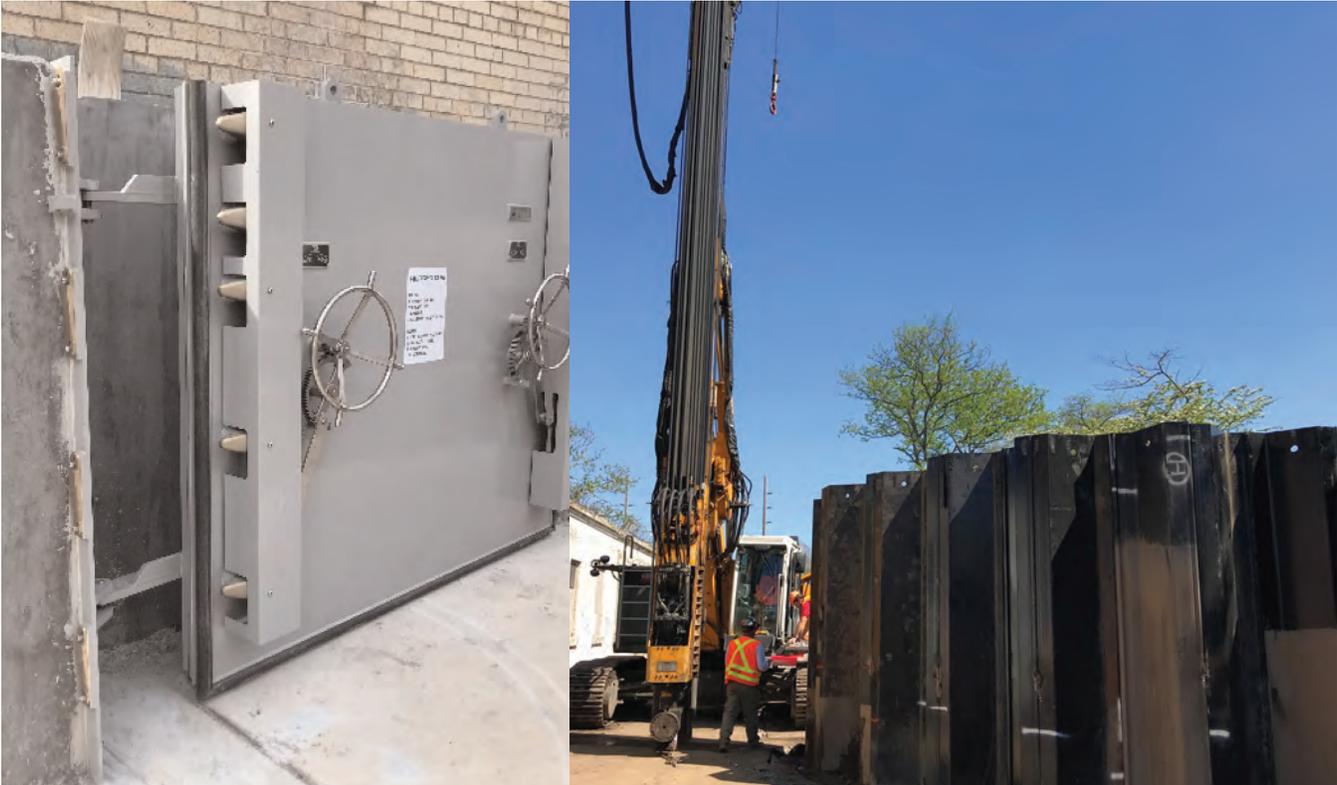
FIGURE 6: DUAL PURPOSE FLOOD AND DEBRIS WALL INSTALLED AROUND HAMMELS WYE FACILITY AND FAR ROCKAWAY BRANCH.

*Project Description:* The Rockaway A subway line is an above-ground and low-level track that suffered extensive damage during Superstorm Sandy. Track and key system restorations are complete and future resiliency measures include the protection of critical assets with a 13,000 foot dual-purpose flood and debris wall.

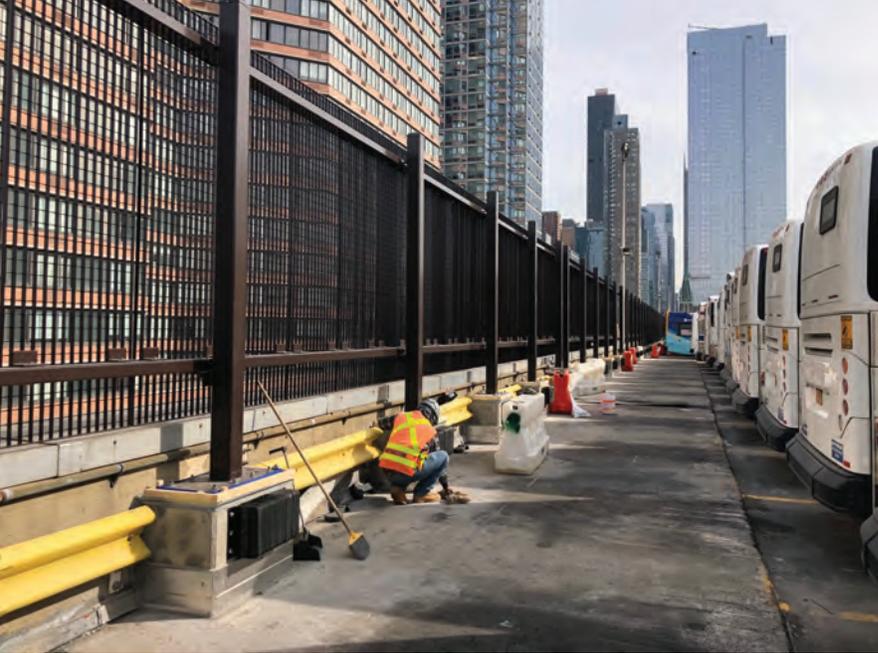
FIGURE 7: DEBRIS WALL ON THE PERIMETER OF THE MICHAEL J. QUILL BUS DEPOT.

*Project Description:* This project will enhance the roof protection at Michael J. Quill Bus Depot. A new mesh debris shield is near completion along the parapet edge and the exterior west-facing wall of the roof. This project is also part of the MTA's Small Business Federal Mentoring Program (SBFMP).

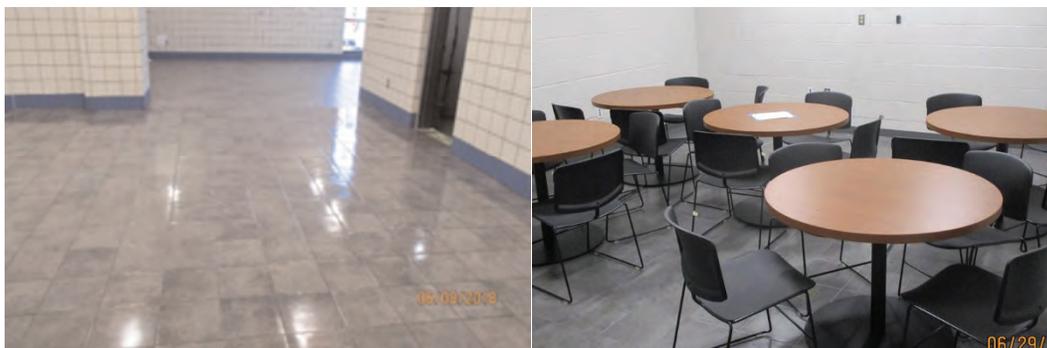
FIGURE 8: WATERPROOF FLOOR AND WALL TILING.

*Project Description:* This project repaired damages to the Far Rockaway Depot that occurred as a result of Superstorm Sandy. Work focused on the bus maintenance and service areas, interior office spaces, employee facilities, various fixed/non-fixed equipment, electrical distribution equipment, and flood proofing of the facility.

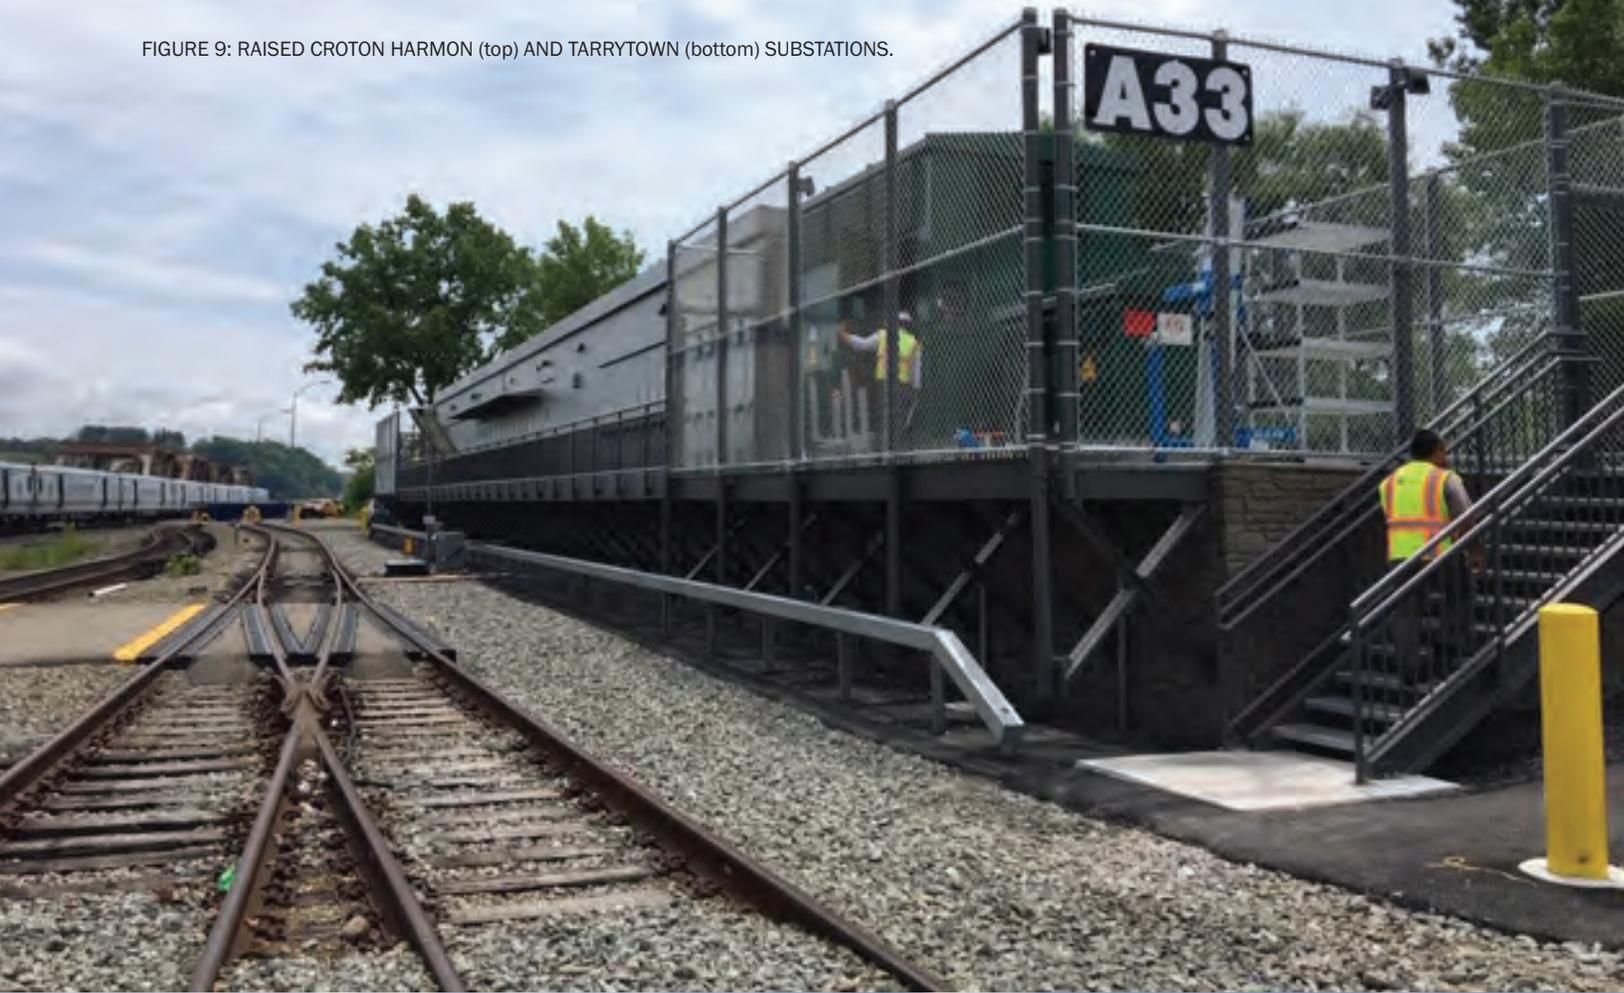
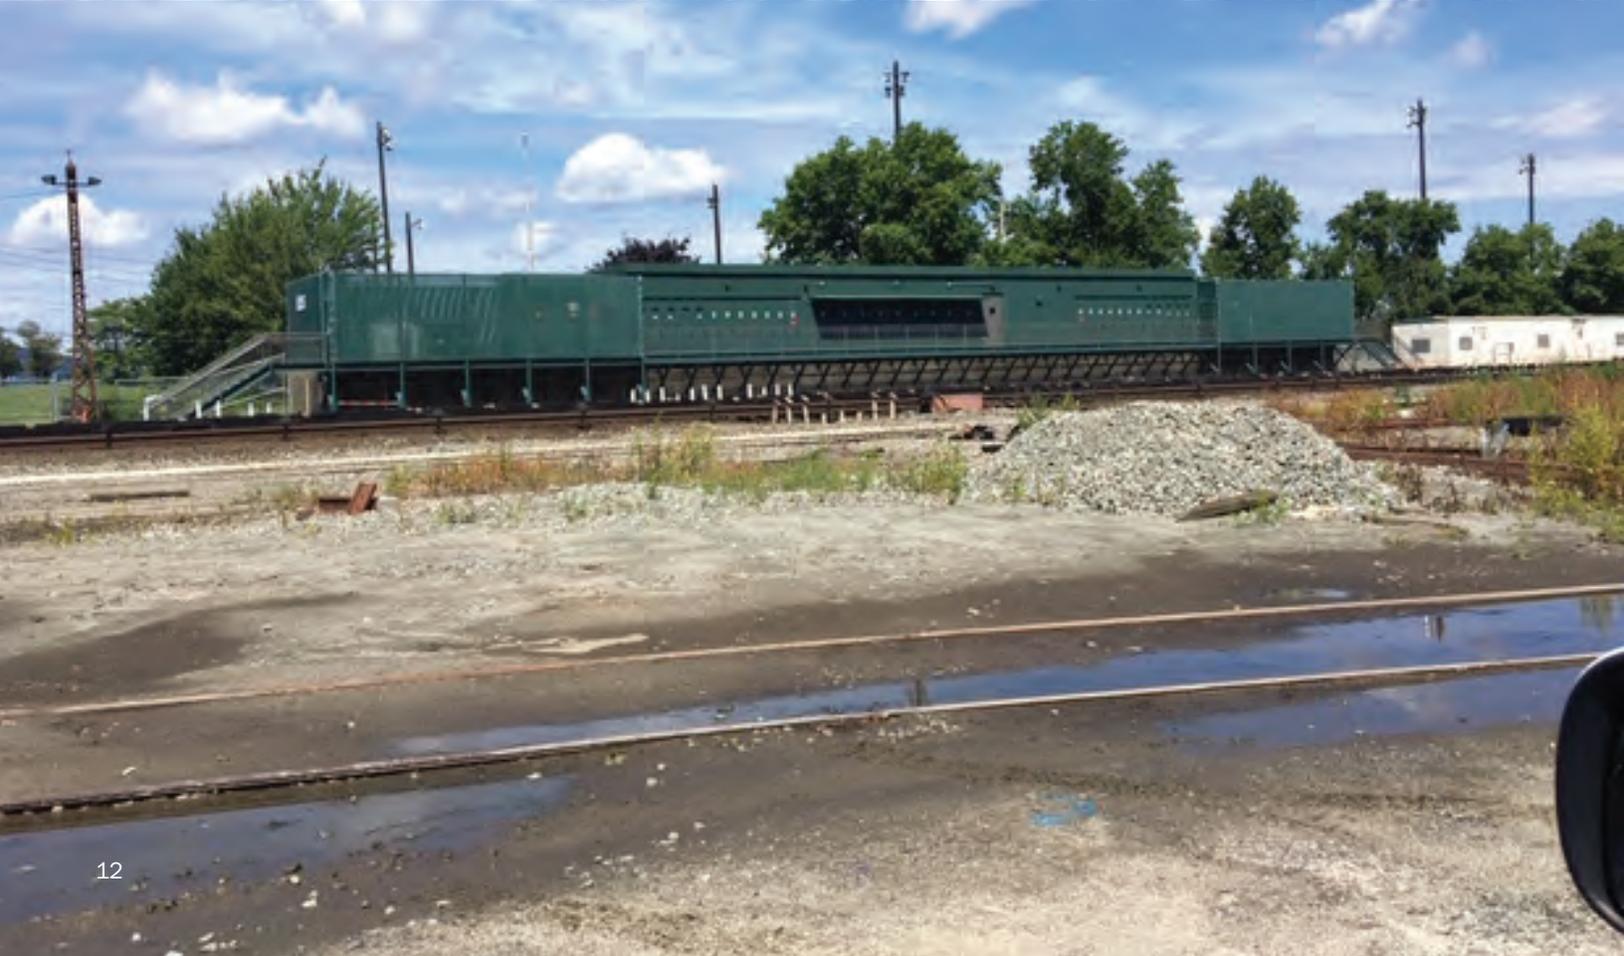
FIGURE 9: RAISED CROTON HARMON (top) AND TARRYTOWN (bottom) SUBSTATIONS.

*Project Description:* The scope requires the raising of three specific DC traction power substations on the Hudson Line that were damaged by Superstorm Sandy. The Hudson Line substations included in this scope are Riverdale, Tarrytown, and Harmon Yard.

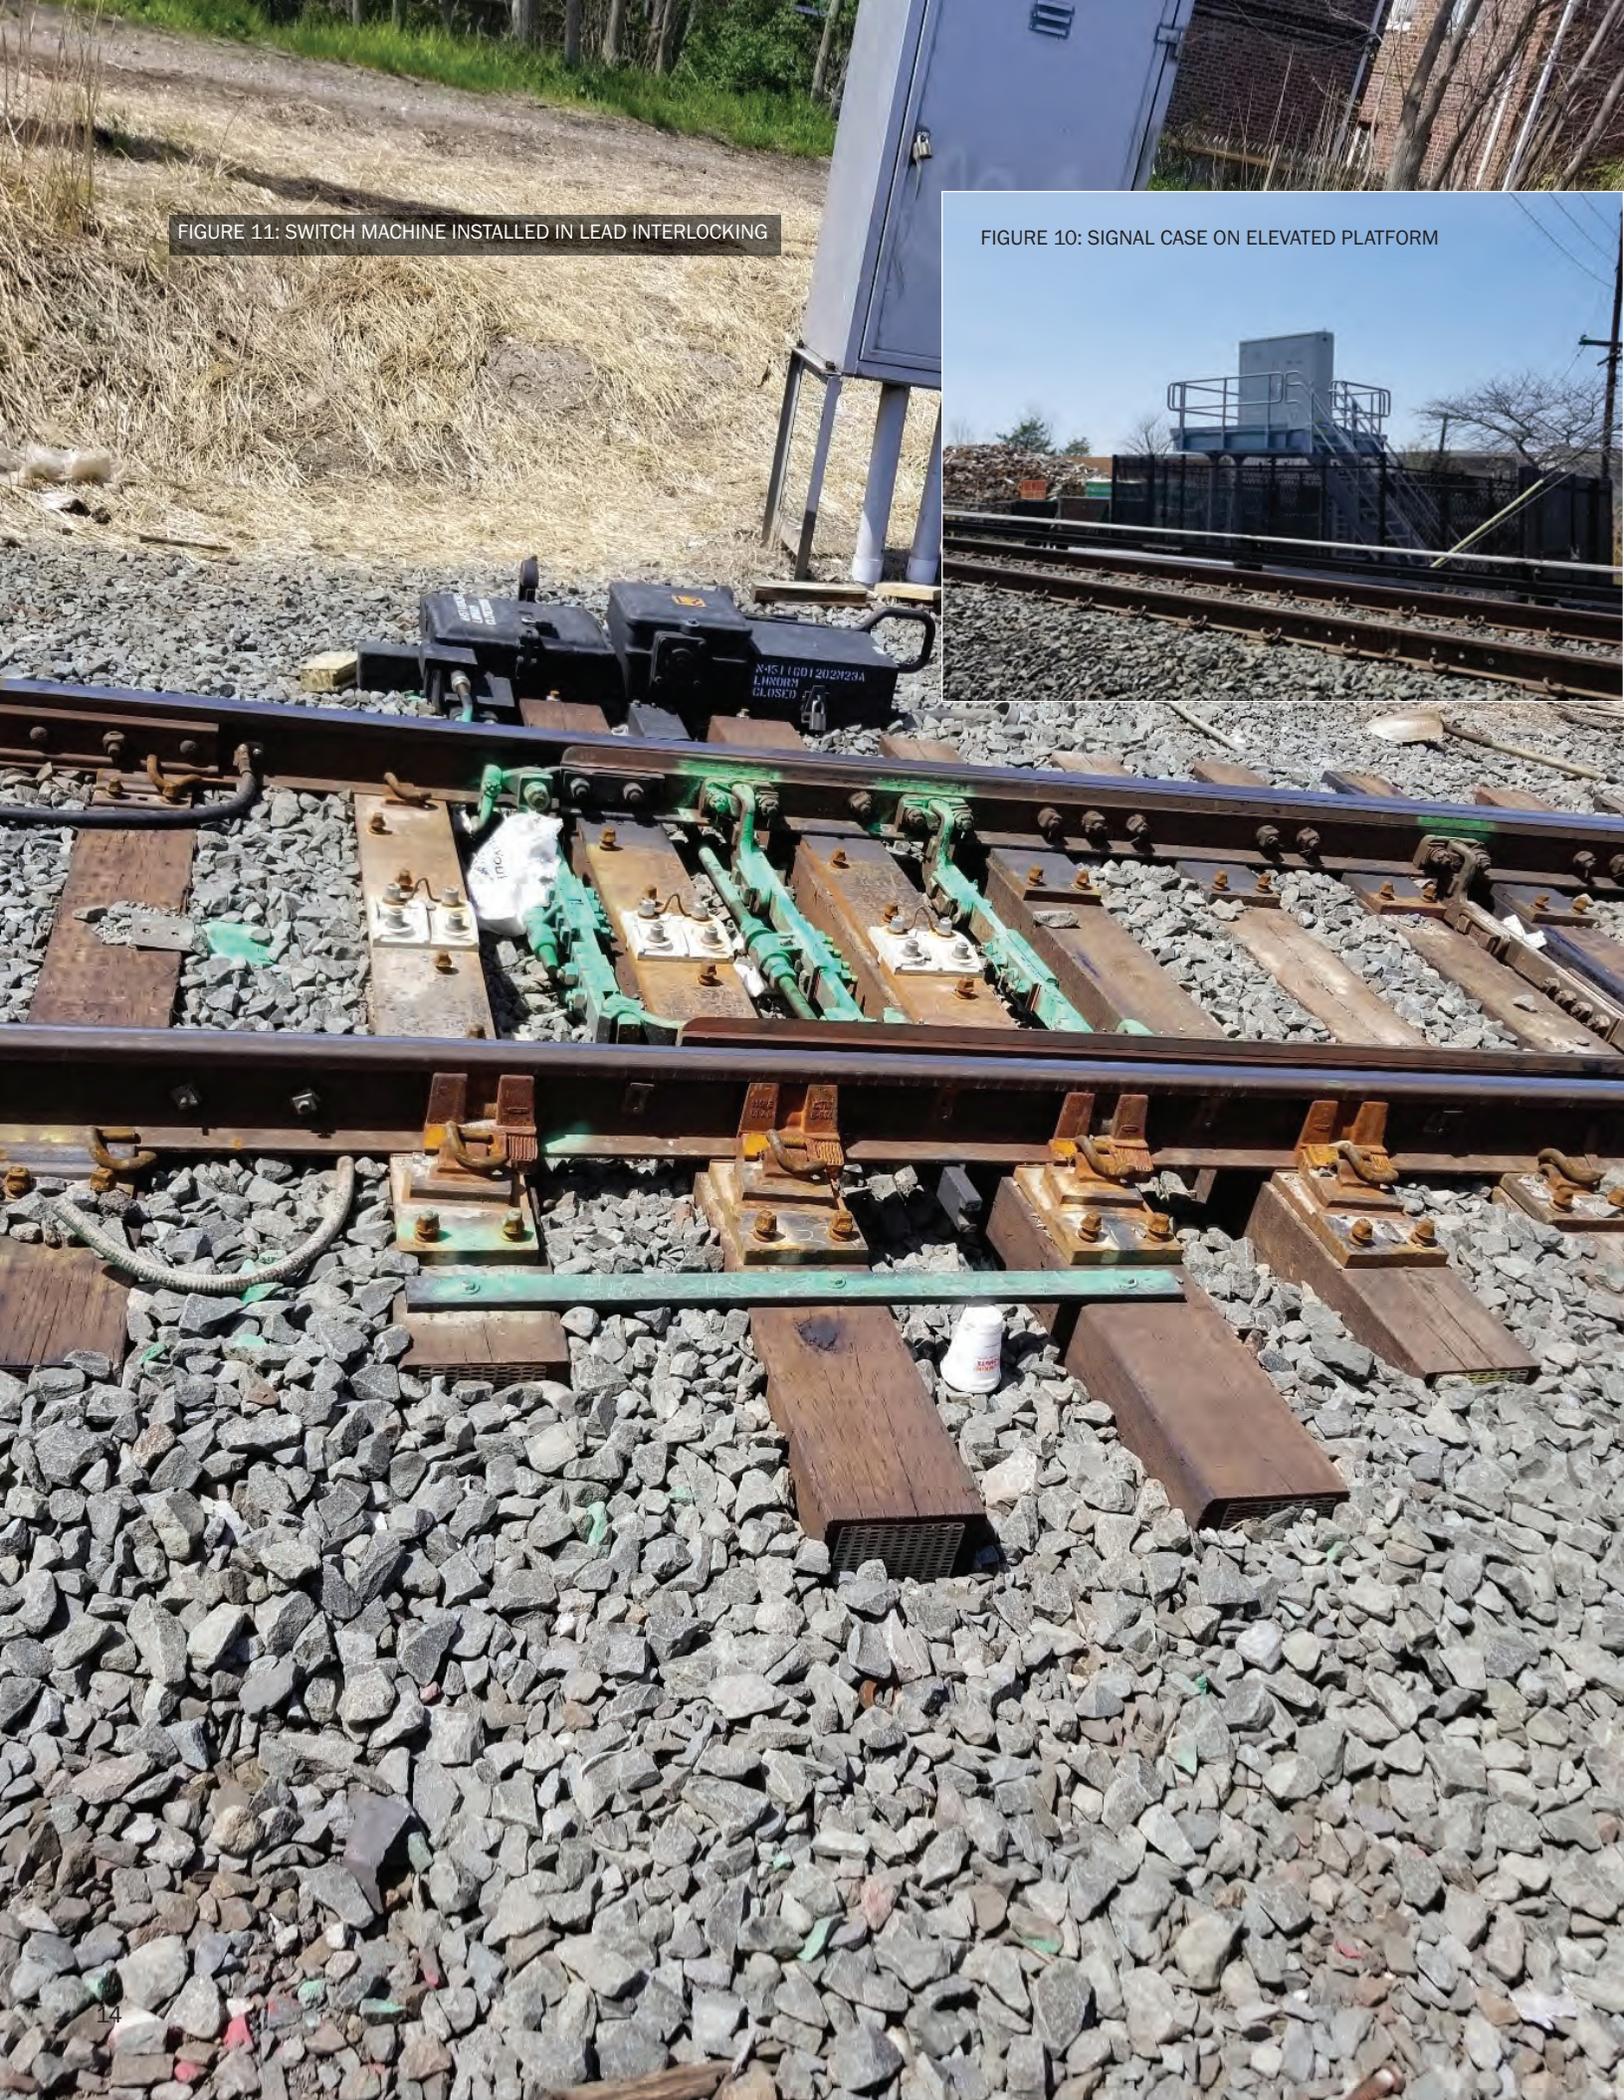
FIGURE 10: SIGNAL CASE ON ELEVATED PLATFORM

*Project Description:* The Sandy Hudson Line Power/C&S Infrastructure Design-Build Project replaces existing damaged, degraded, or destroyed critical power and C&S (communications and signals) systems infrastructure along the flood prone MNR Hudson Line, making these systems more resilient in order to prevent or limit future damage that would degrade power and C&S electrical continuity.

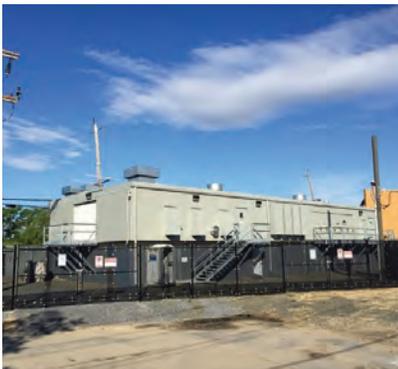
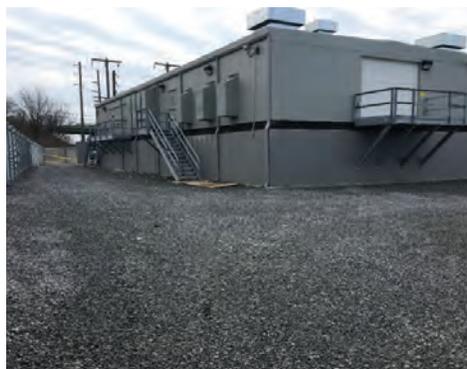
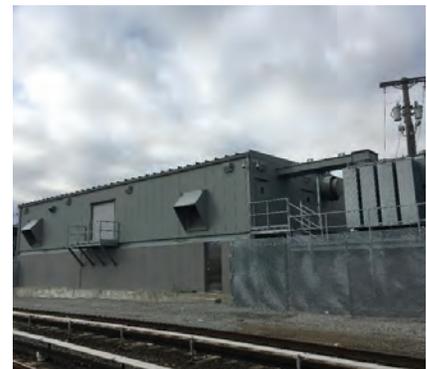
FIGURE 12: FROM LEFT TO RIGHT, RAISED SUBSTATIONS AT OCEANSIDE, OIL CITY, AND LONG BEACH.

*Project Description:* Replace three Long Beach Branch substations at Oceanside, Oil City and Long Beach Yard damaged by Superstorm Sandy storm surge flooding.

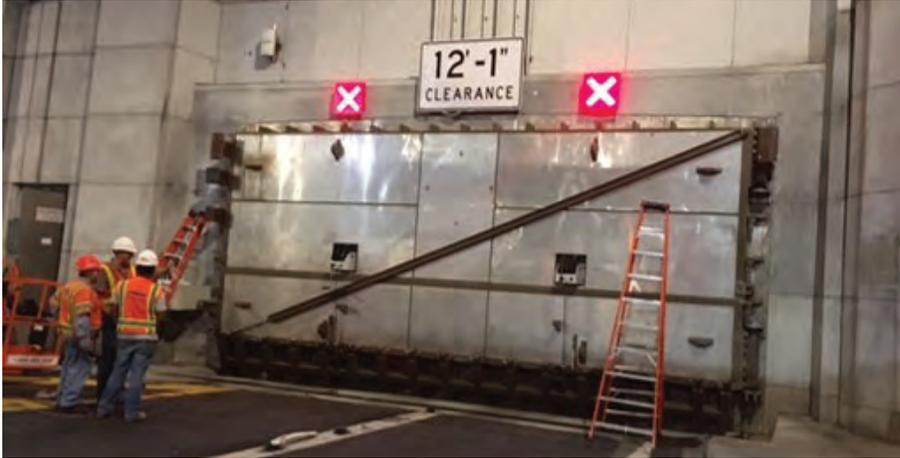
FIGURE 13: PORTAL FLOOD GATE AT HLCT MANHATTAN WEST IN CLOSED POSITION

*Project Description:* The Hugh L. Carey Tunnel flooded with approximately 60 million gallons of saltwater during Superstorm Sandy. Short-term adaptations for this high-trafficked, Manhattan-Brooklyn connection included flood-proofing and relocating the data center above FEMA 500-year flood level. Long-term adaptations included the installation of deployable and permanent barriers at each tunnel plaza to form a protected perimeter, installation of hinged steel flood gates at tunnel portals, installation of emergency generator, installation of seawall at Governors Island Ventilation Building, replacement of drainage pumps, and other flood mitigation measures.

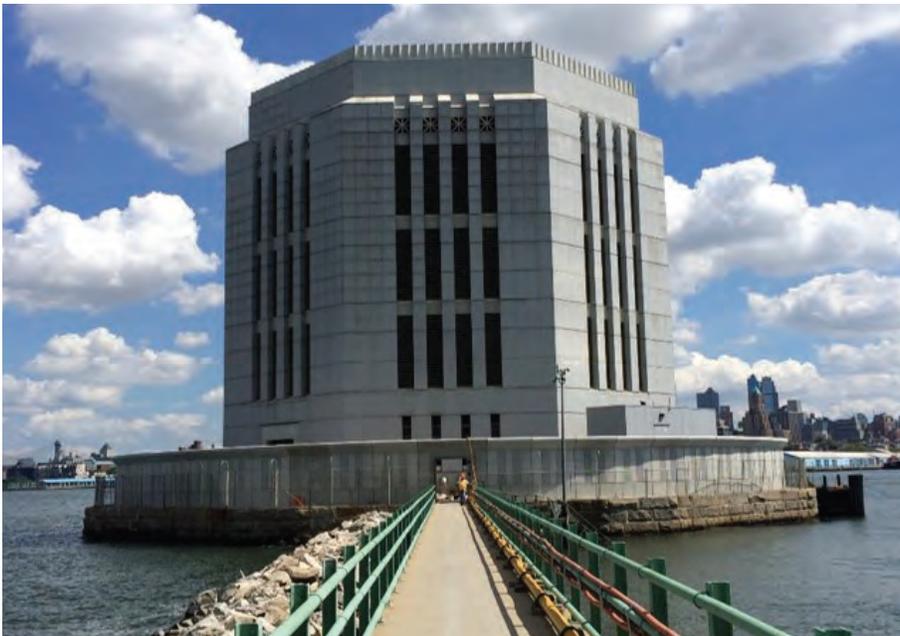
FIGURE 15: DEPLOYABLE AQUAFENCE BARRIERS

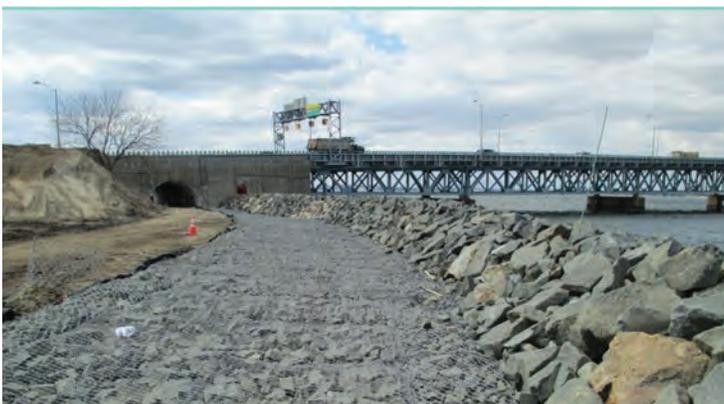
FIGURE 16: RESTORED SEAWALL AND PEDESTRIAN WALKWAY AT MARINE PARKWAY BRIDGE

*Project Description:* Two toll bridges, the Marine Parkway Bridge and the Cross Bay Bridge, on the Rockaway Peninsula suffered flood damage during Superstorm Sandy. Resiliency efforts included repairing the seawall and shoreline and raising the elevation of electrical equipment and substations.

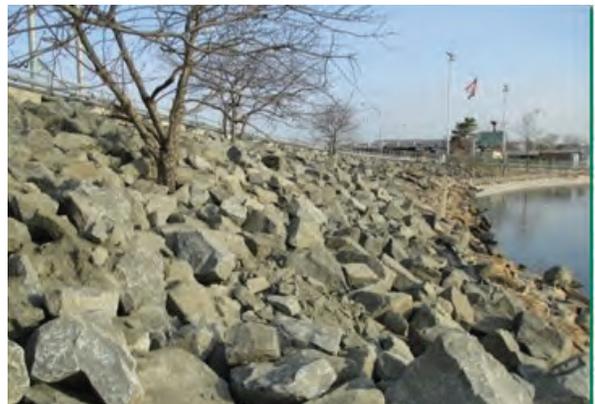
FIGURE 17: RESTORED ABUTMENT AT CROSS BAY BRIDGE

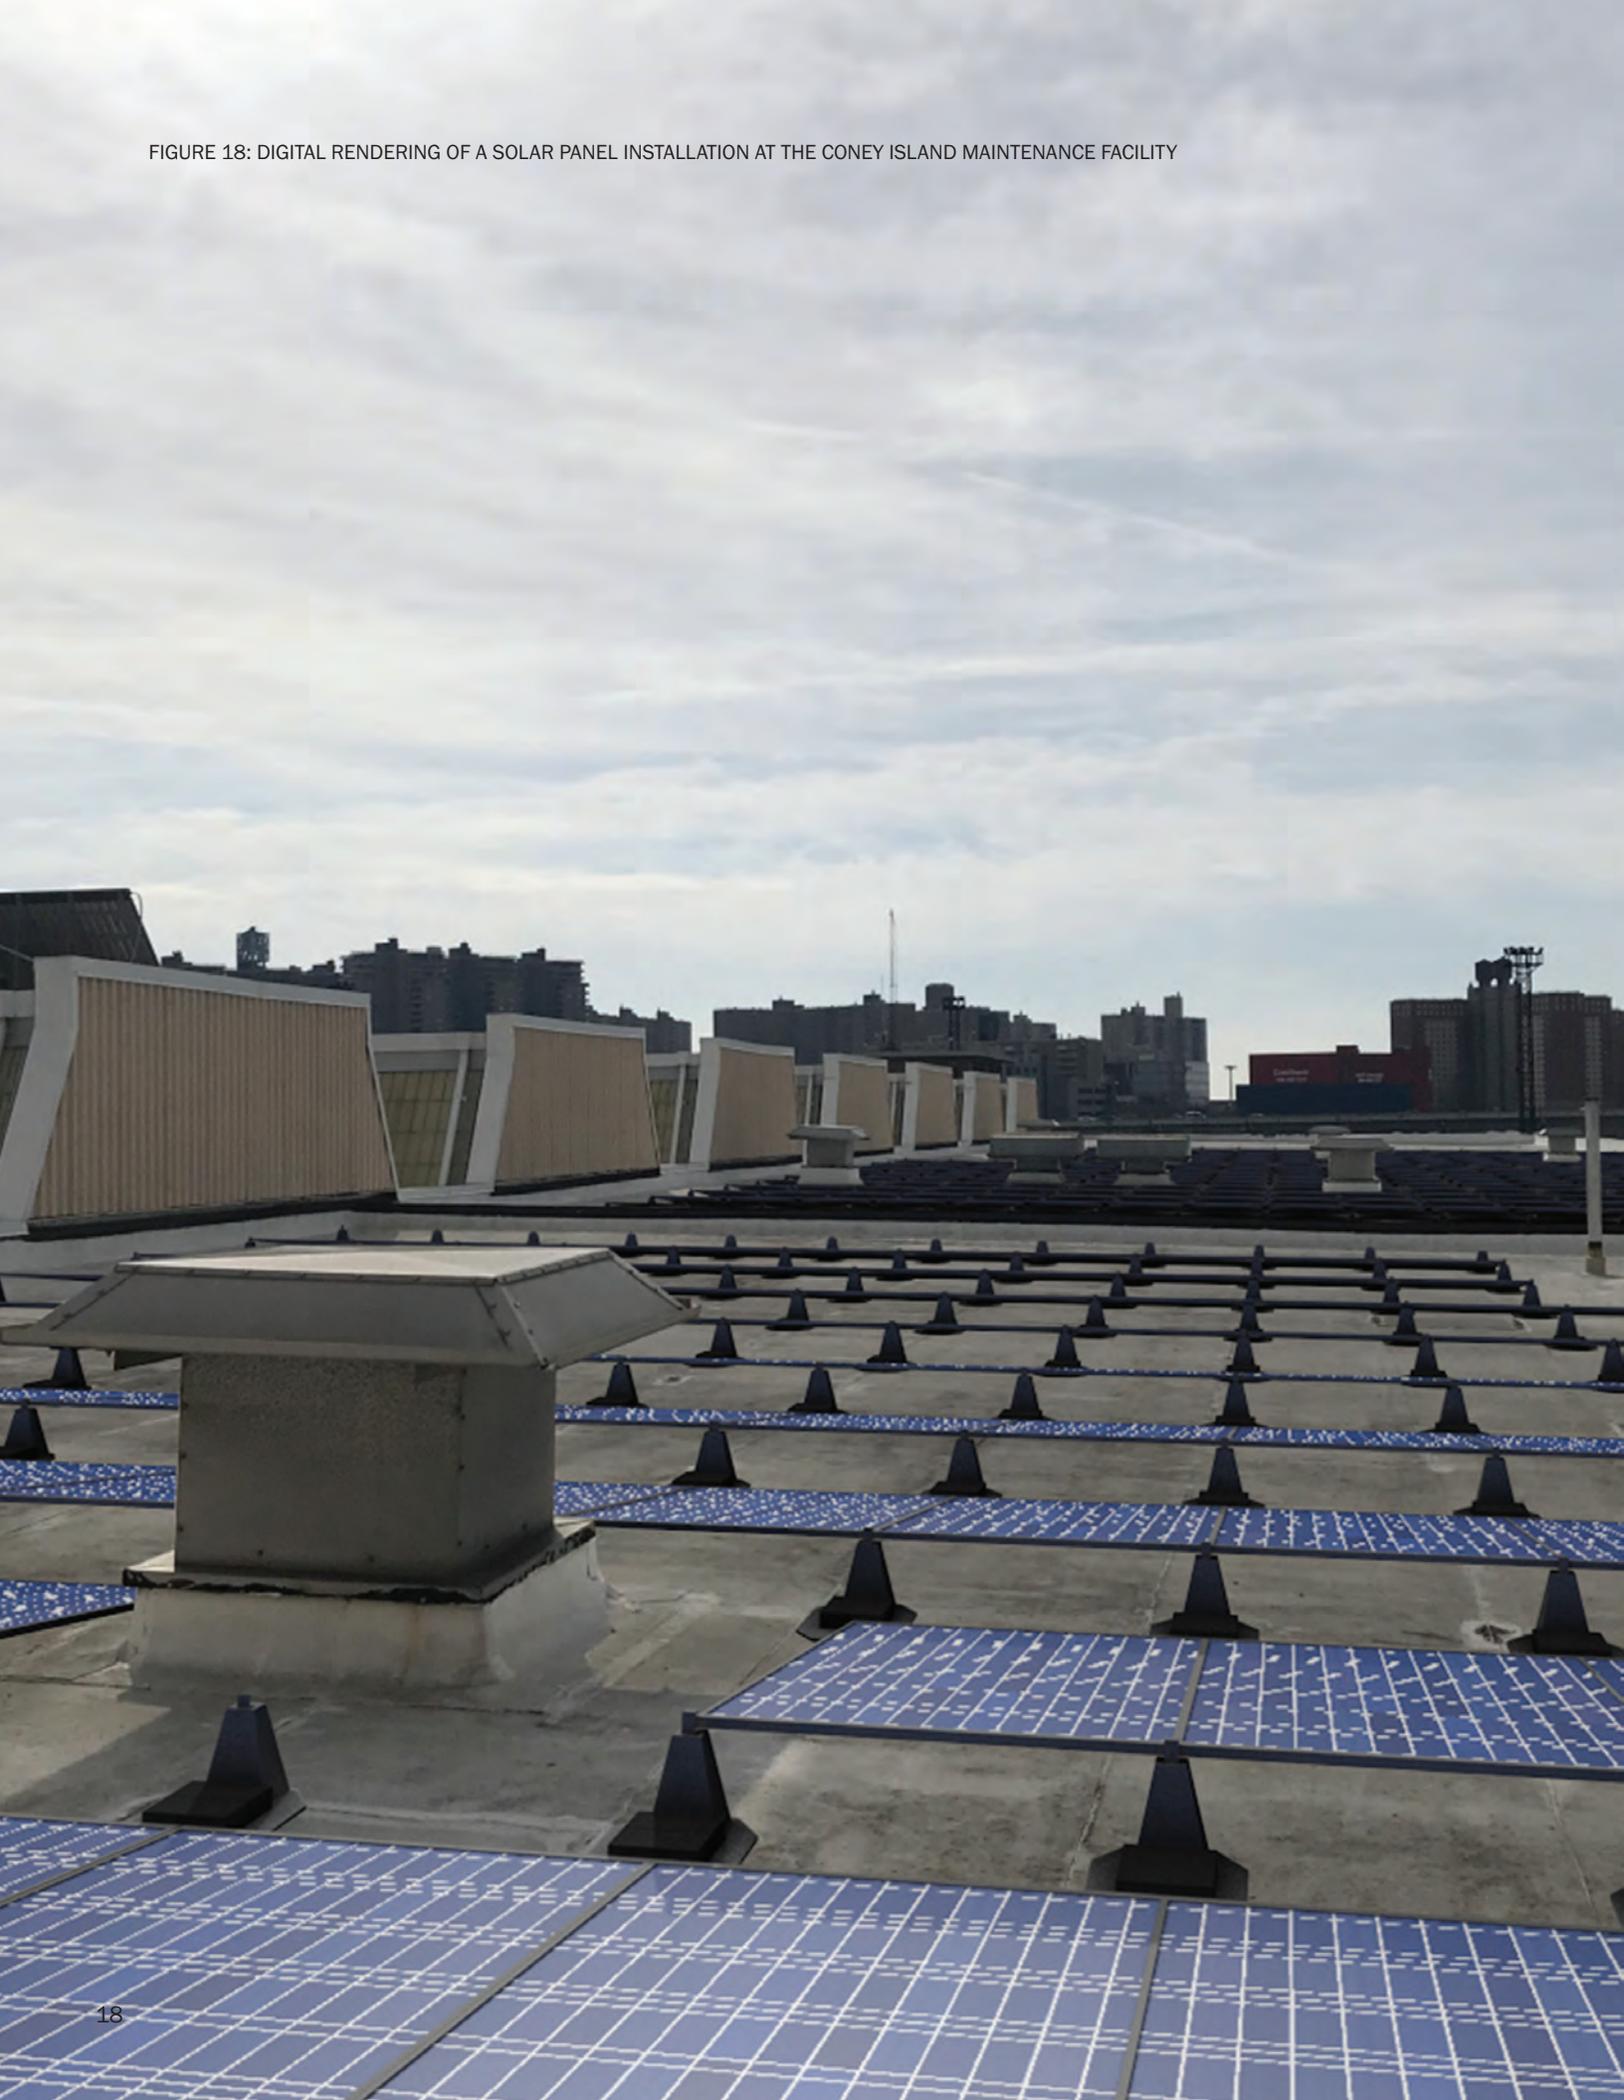
FIGURE 18: DIGITAL RENDERING OF A SOLAR PANEL INSTALLATION AT THE CONEY ISLAND MAINTENANCE FACILITY

The MTA has identified more than 100 bus depots, train yards, repair shops, and commuter lots across all MTA agencies – totaling more than 10 million square feet – that are suitable for solar development. Fully realized, these properties present an opportunity to develop more than 100 megawatts of emission-free electricity for New Yorkers – enough to power 18,000 households. The MTA hopes to achieve a significant new revenue stream from this activity, with little to no capital investment of its own. MTA Solar creates a new path for the MTA to lead in Climate Change mitigation.

**Roofs are an important asset** in both climate adaptation and mitigation. As part of our climate adaptation portfolio, the MTA has planted green roofs to absorb precipitation, reduce storm water discharge, and alleviate the urban heat island effect. These initiatives, however, do come with a capital cost. Looking forward, as we expand our focus to include climate mitigation, we are continuing to leverage roofs as an asset, but with an alternative financing structure.
